Site Analysis American Creosote Works, Inc. Jackson, Tennessee

EPA Region 4
and OERR

Remedial Response and
Site Analysis
American Creosote Works, Inc.
Jackson, Tennessee

by
Judith M. Begley, Imagery Analyst
The Pionetics Corporation
Warrenton, Virginia 22186

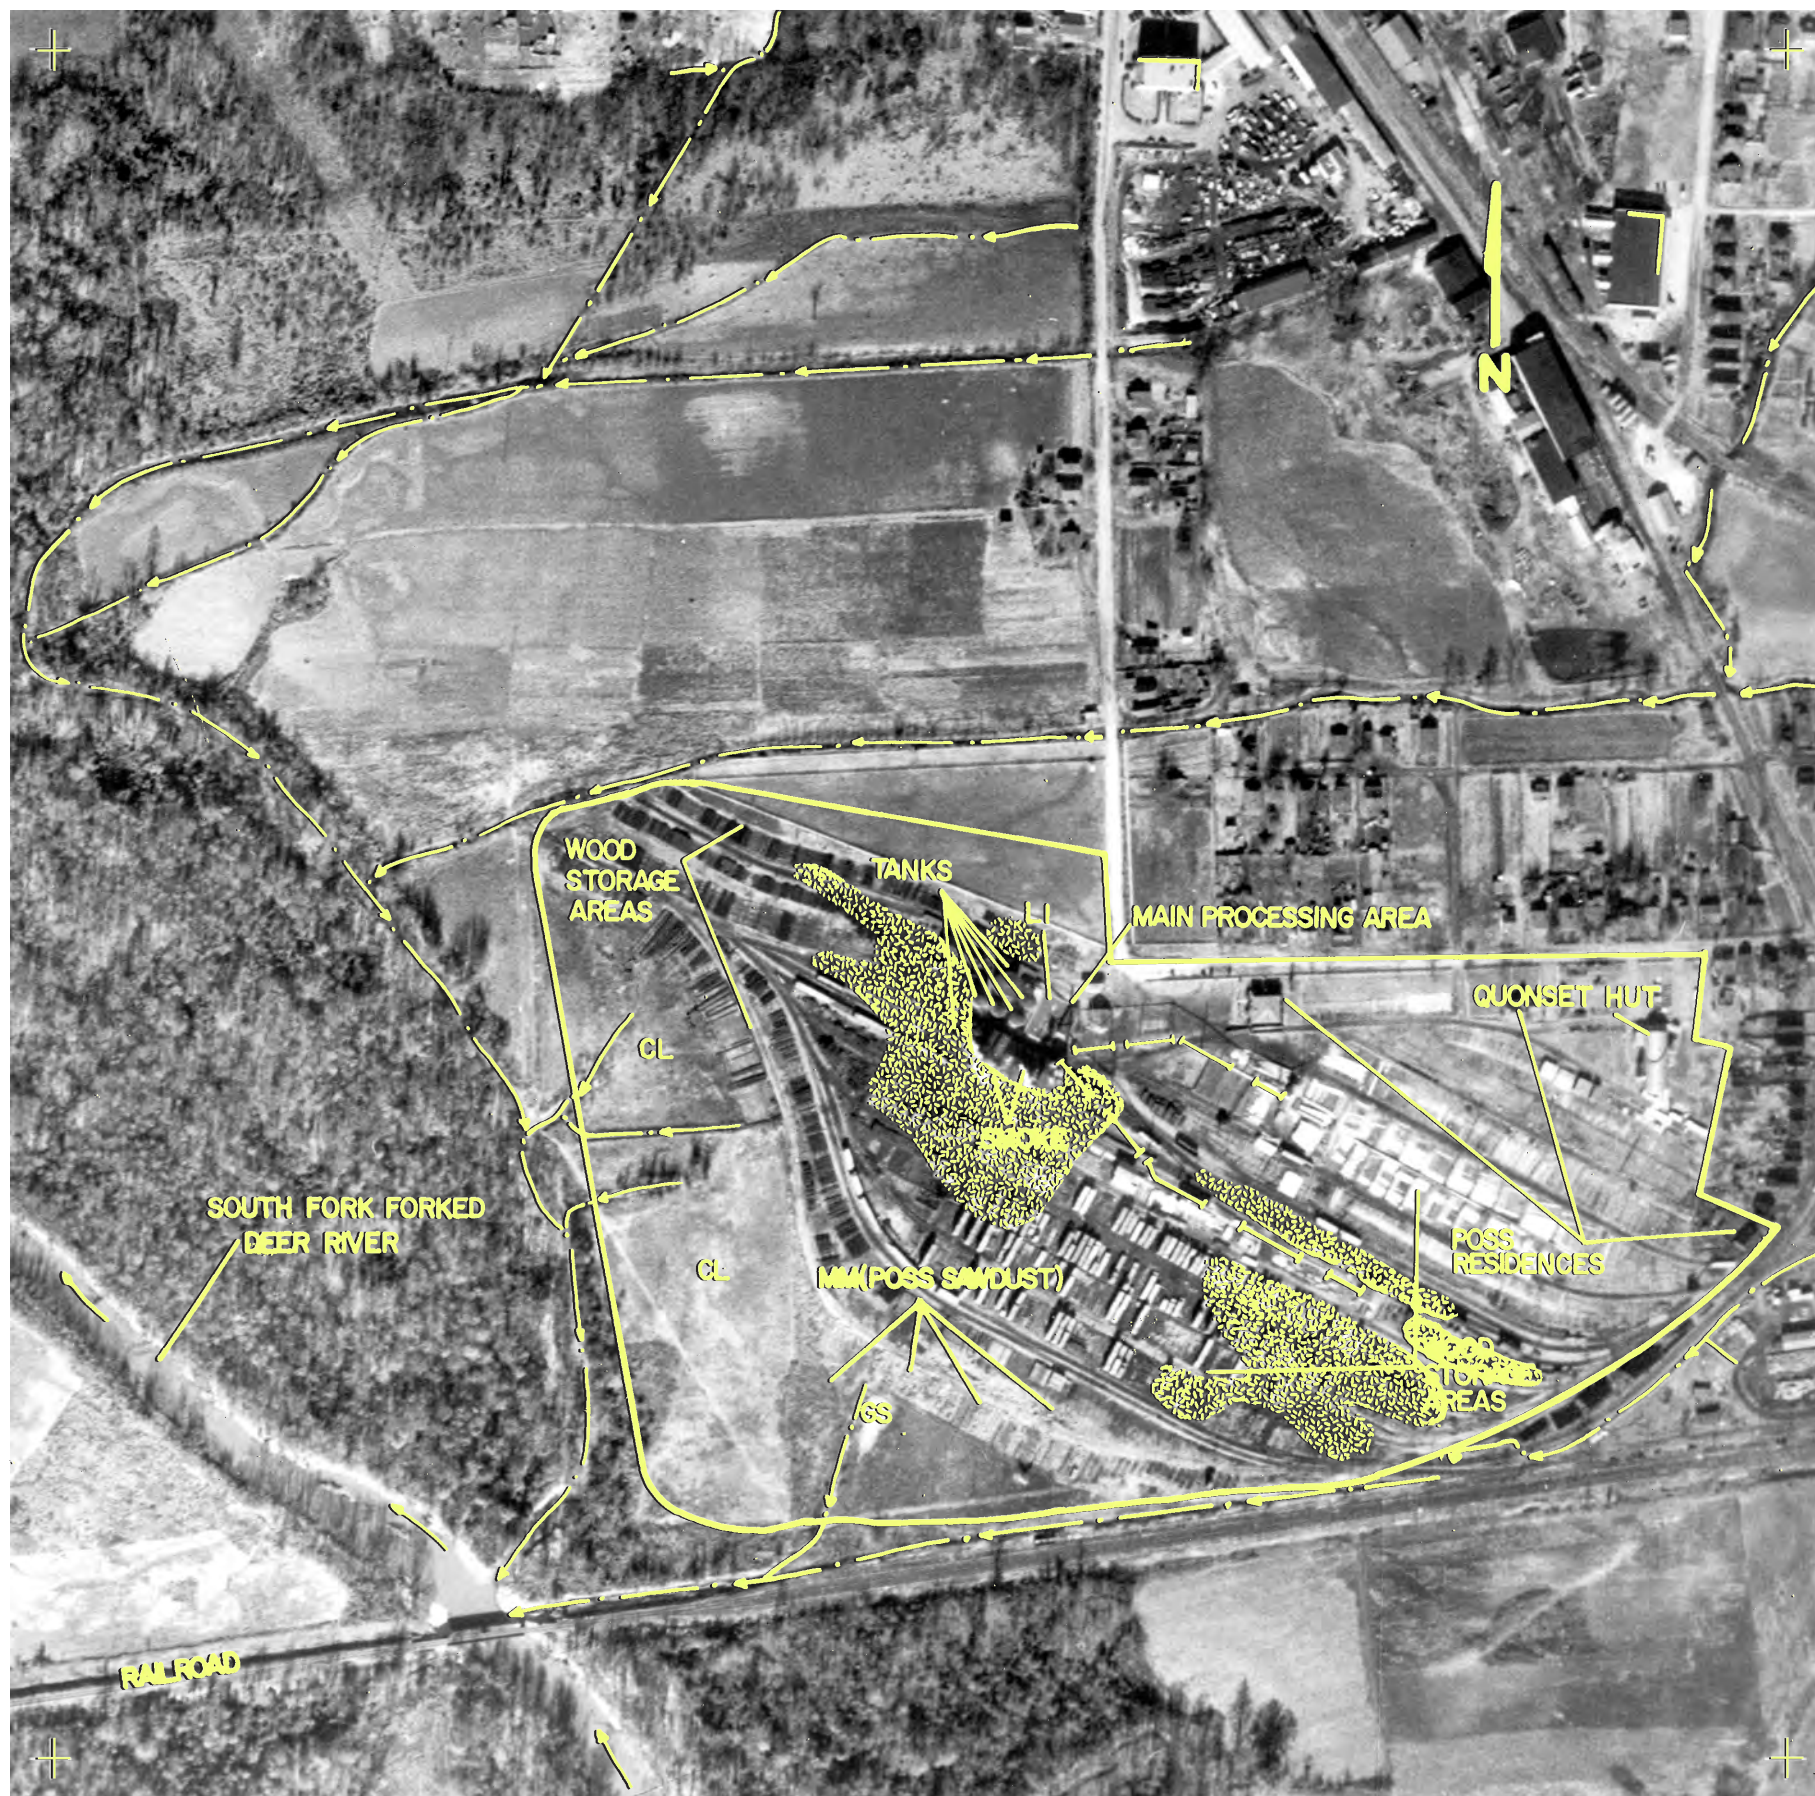
Figure 3. American Creosote Works, December 18, 1950.
Approximate scale 1:3,900.

Two plumes of smoke are rising from the large building at the main processing area. A nearby rectangular, apparently concrete-walled, lagoon (L1) contains light-toned liquid. The soil in most of the wood storage areas appears darker in tone than the natural soil in the general area. On the west side of the site trees have been cleared from the area (CL) between the storage piles and a large drainage channel. Mounded material (MM) (possibly sawdust) and a light-toned ground scar (GS) are visible along the southwest edge of the wood storage area.

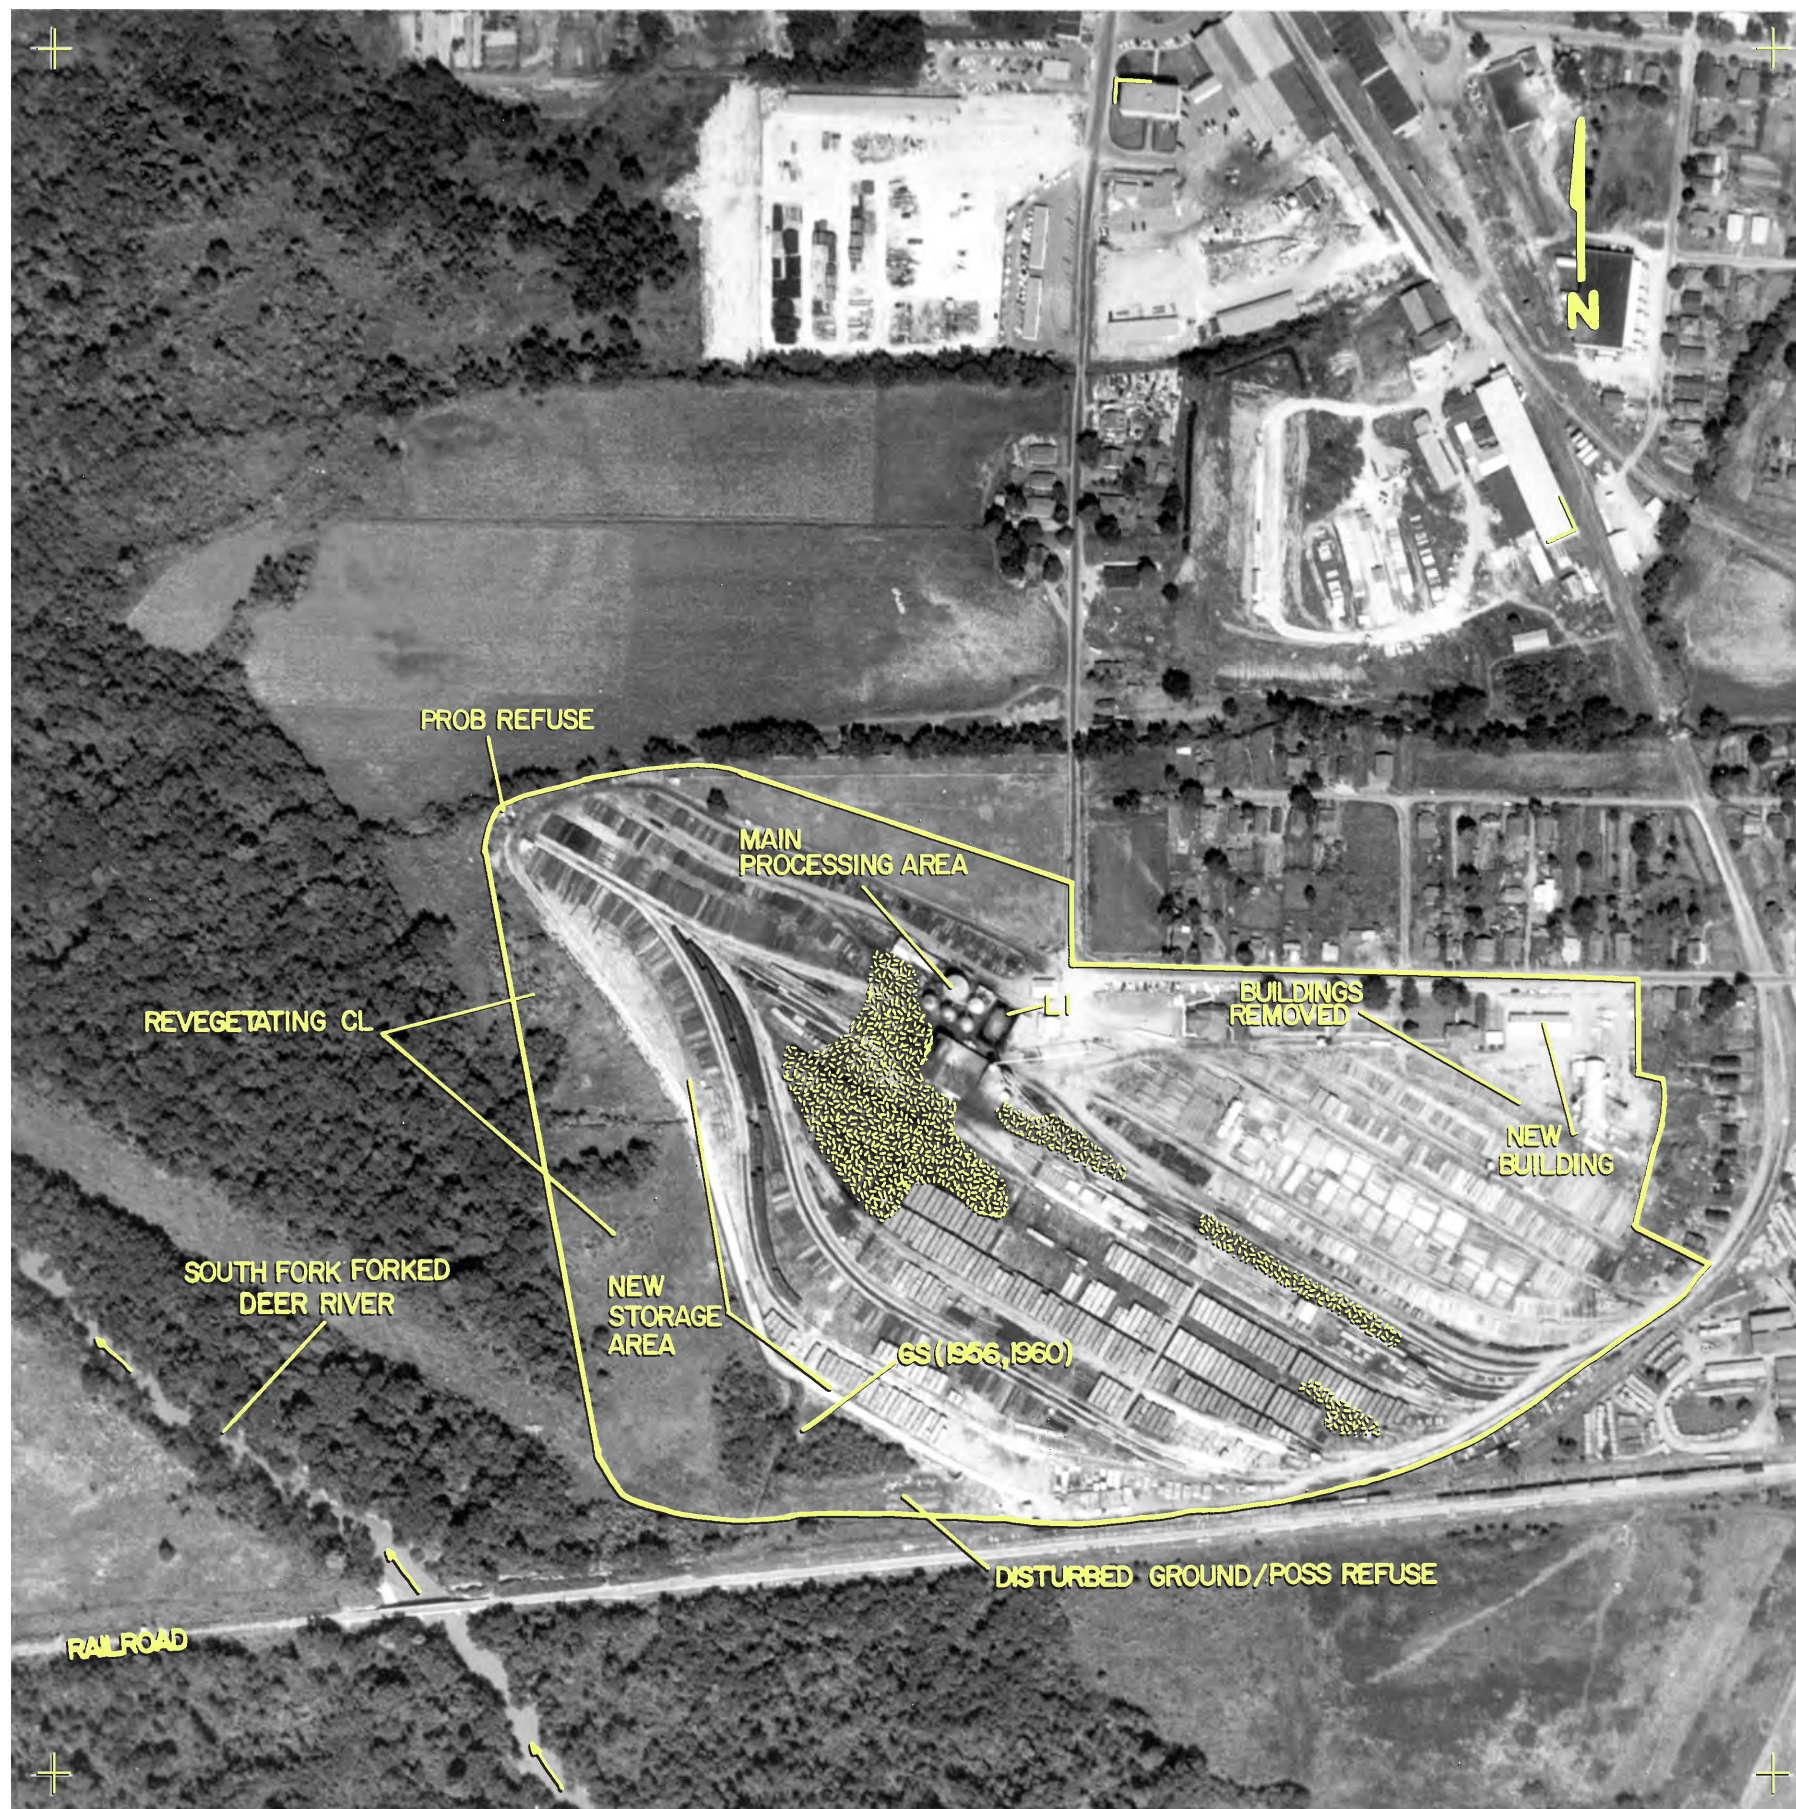
Figure 4. American Creosote Works, September 14, 1960.
Approximate scale 1:3,900.

Between 1950 and 1956 the site was cleared and neatened to some degree. The general tone of the ground became lighter and the piles of wood were stacked more regularly. The wood storage area expanded along the south and southwest portions of the storage areas visible in 1950, including the area where the possible sawdust was visible.

Little change has occurred onsite since 1956. Probable scattered refuse is visible in the northwest corner of the site, and an area of disturbed ground and small objects, possibly refuse, are present in the southern portion of the site. Light- and dark-toned liquid is visible in L1.

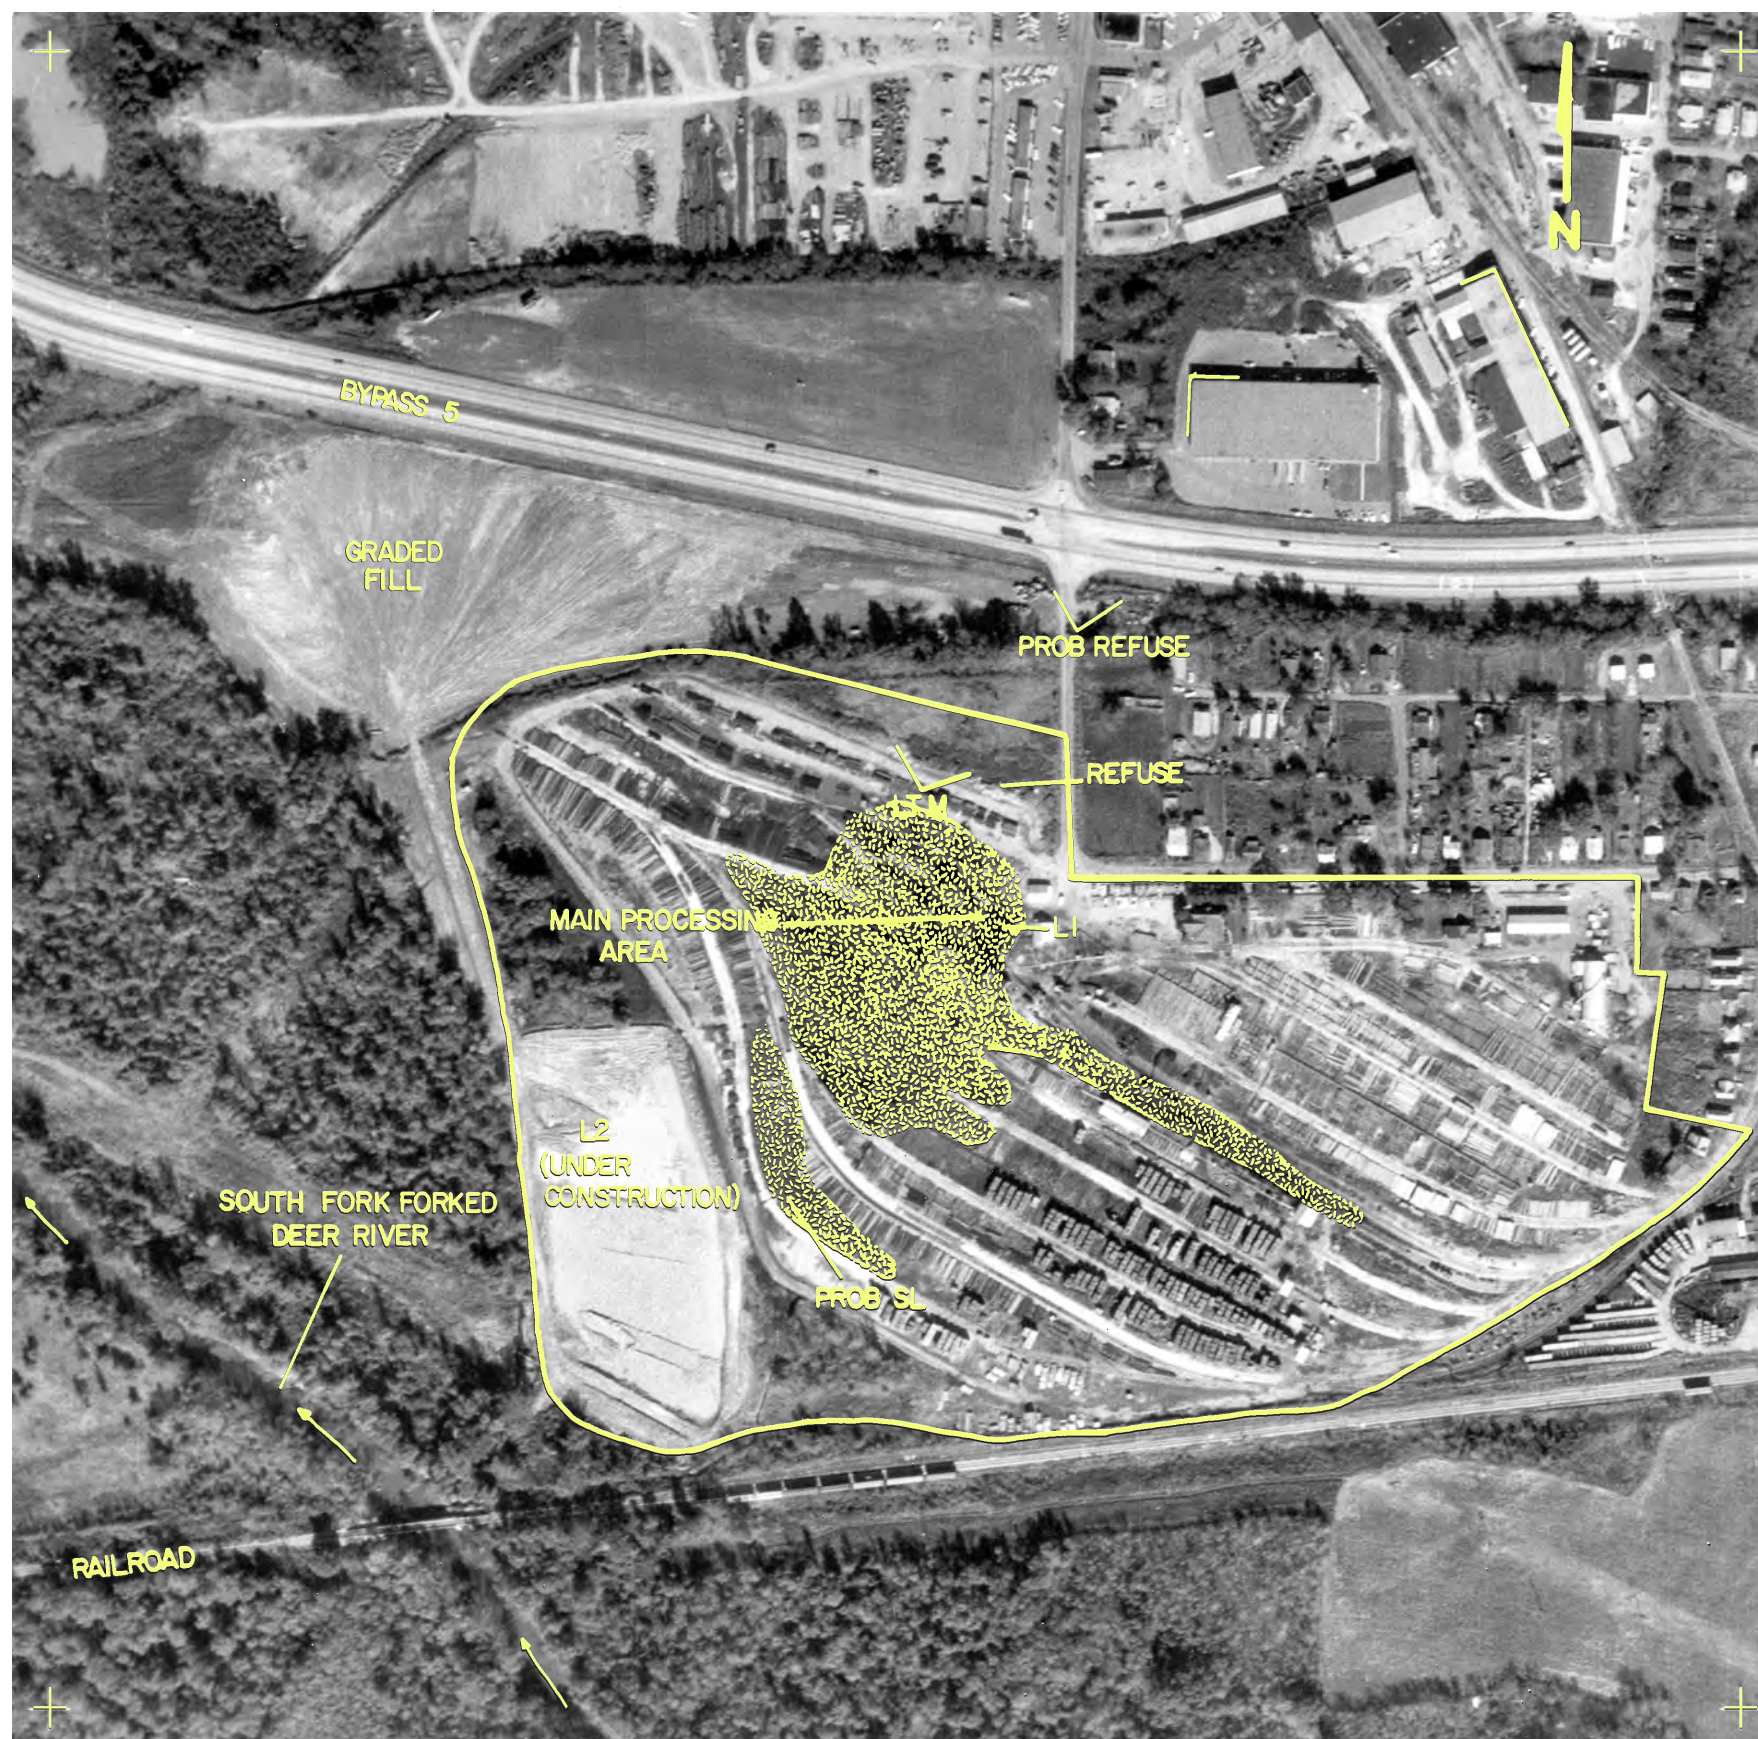
Figure 5. American Creosote Works, November 8, 1971.
Approximate scale 1:3,900.

A large revetted lagoon (L2) is under construction in the southwest corner of the site. An area of graded fill that may have been receiving spoils from the lagoon is present northwest of the site. Light-toned material (LT M) and refuse are visible on the north edge of the site. Two large piles of probable refuse are present adjacent to the newly constructed Bypass 5 on either side of the site access road. L1 contains dark liquid. A small pool of probable standing liquid (SL) is present in a dark-toned area east of L2.

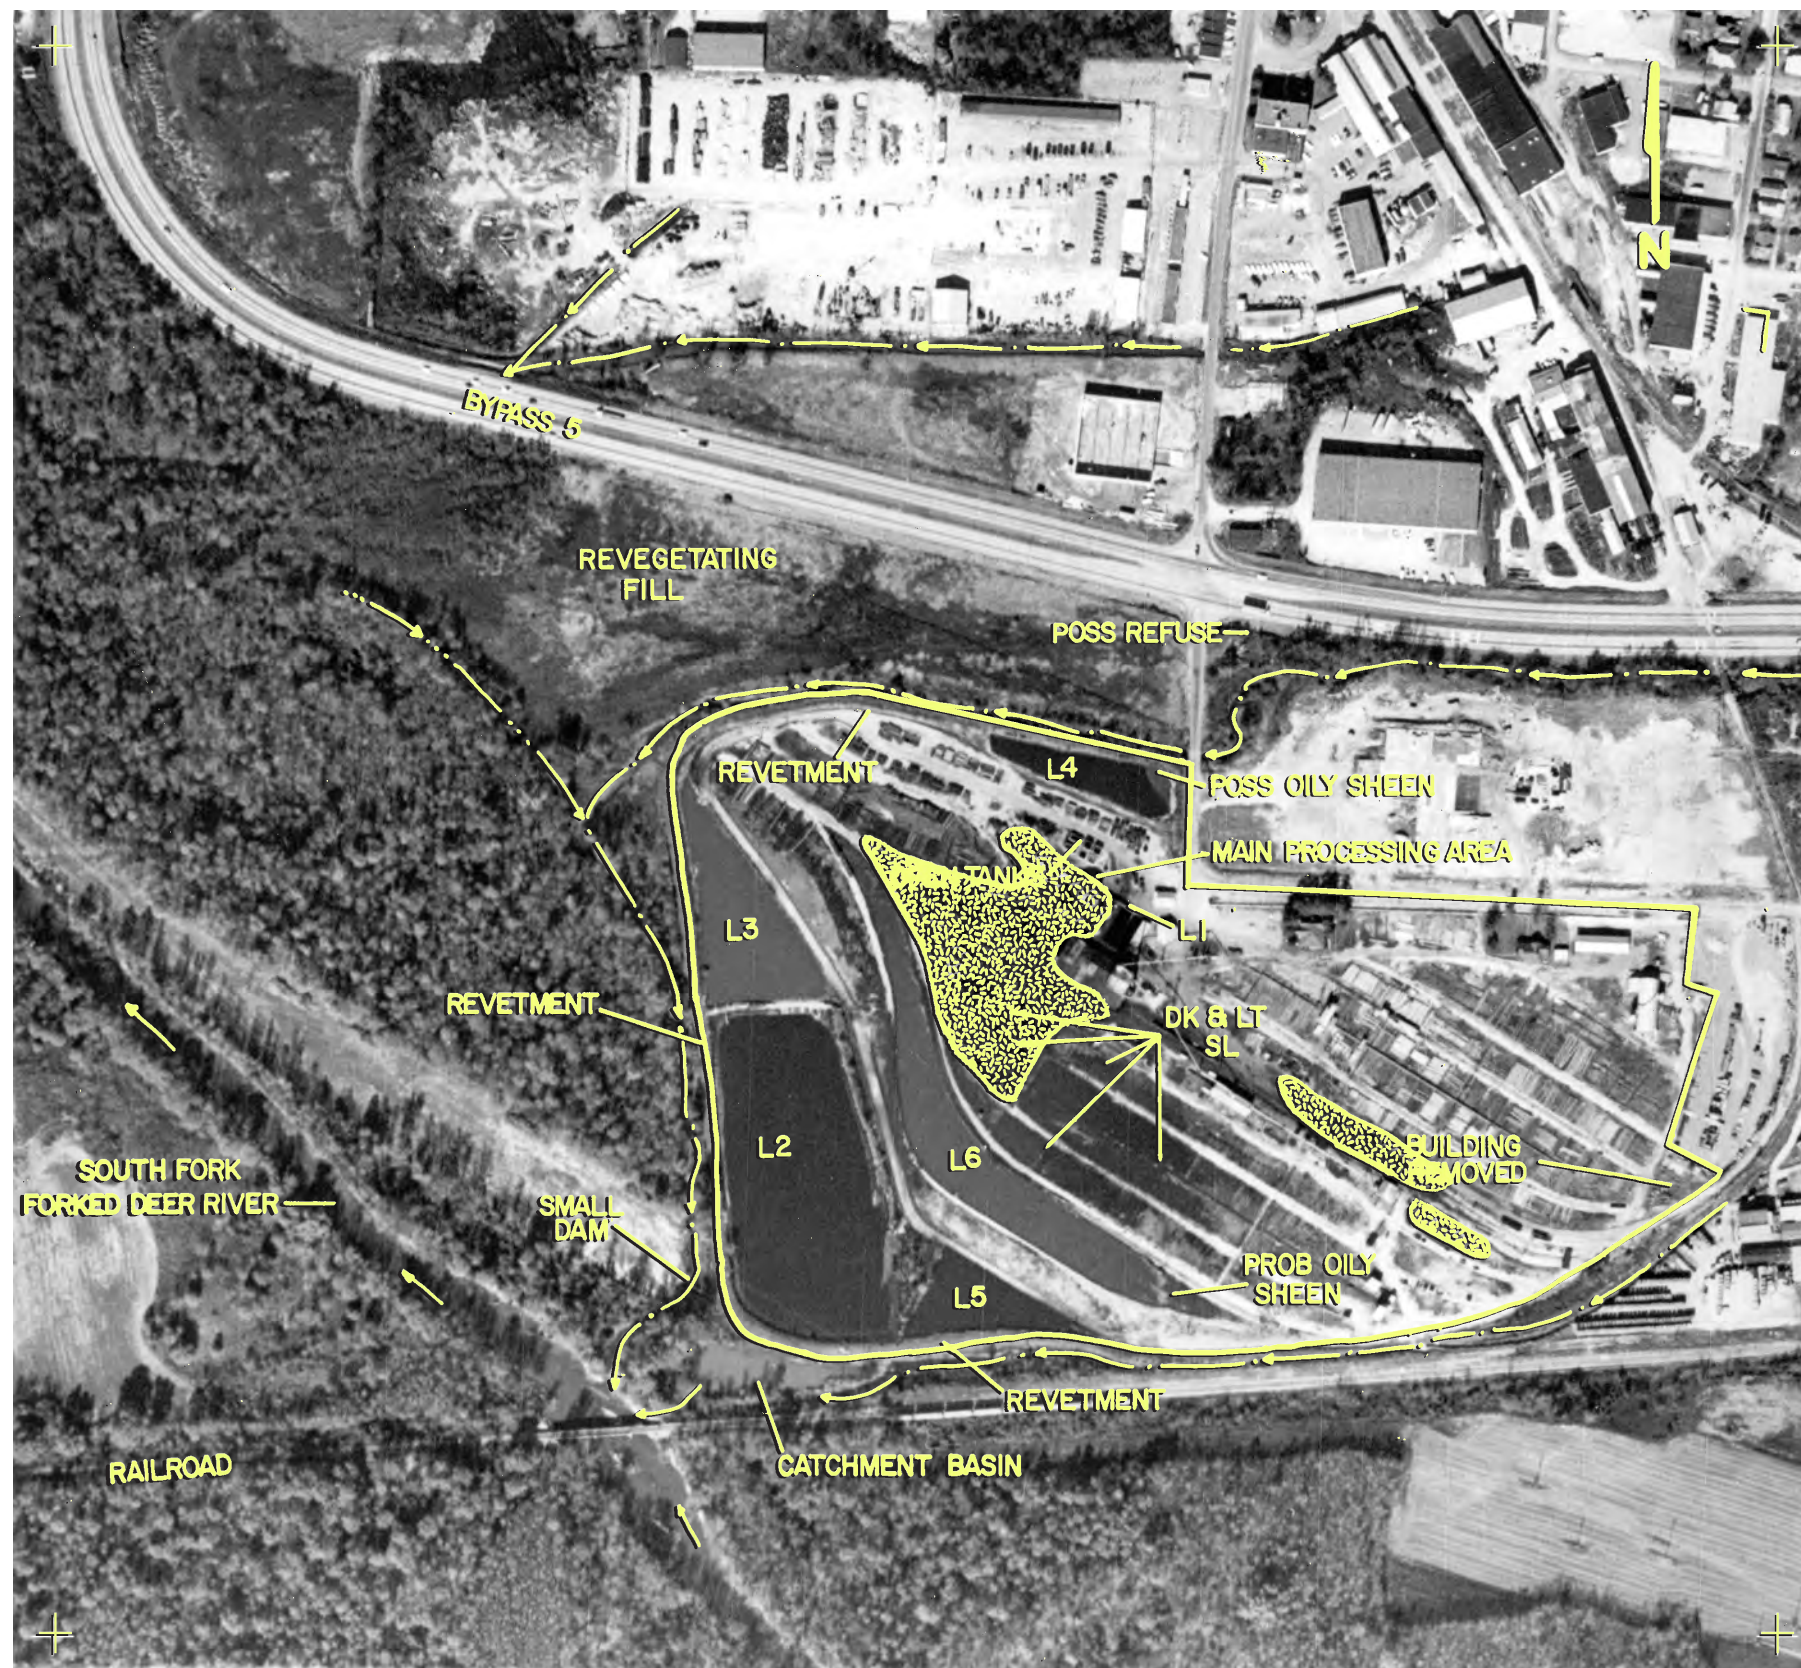
Figure 6. American Creosote Works, November 17, 1979.
Approximate scale 1:4,500.

Three additional lagoons (L3-L5) were constructed onsite between 1971 and 1974. All the lagoons contained liquid of various tones in 1974. Runoff from the western portion of the site was channeled into L2. A revetted catchment basin was constructed just outside the southwest corner of the site. Earthen revetments were built along the perimeter of the western half of the site. Additional fill was added to the fill area north of the site. The courses of some of the drainage channels around the site were altered slightly between 1971 and 1974; however, the runoff from the area still eventually entered the South Fork of the Forked Deer River. The inventory of stacked wood onsite decreased dramatically between 1971 and 1974. The large piles of refuse south of Bypass 5 were no longer present in 1974.

The site is partially flooded in 1979. The area labeled L6 may be simply an inundated low area rather than a formal lagoon. Large pools of light- and dark-toned (DK) standing liquid are present between L6 and the main processing area. The liquid in the various lagoons varies in tone. Light-toned areas, which might indicate an oily sheen on the liquid, are annotated. Six new open, square, liquid-filled tanks are present at the main processing area. The inventory of wood onsite has been further reduced since 1974. The fill area northwest of the site has begun to revegetate. A small amount of possible refuse is visible north of the site along Bypass 5.

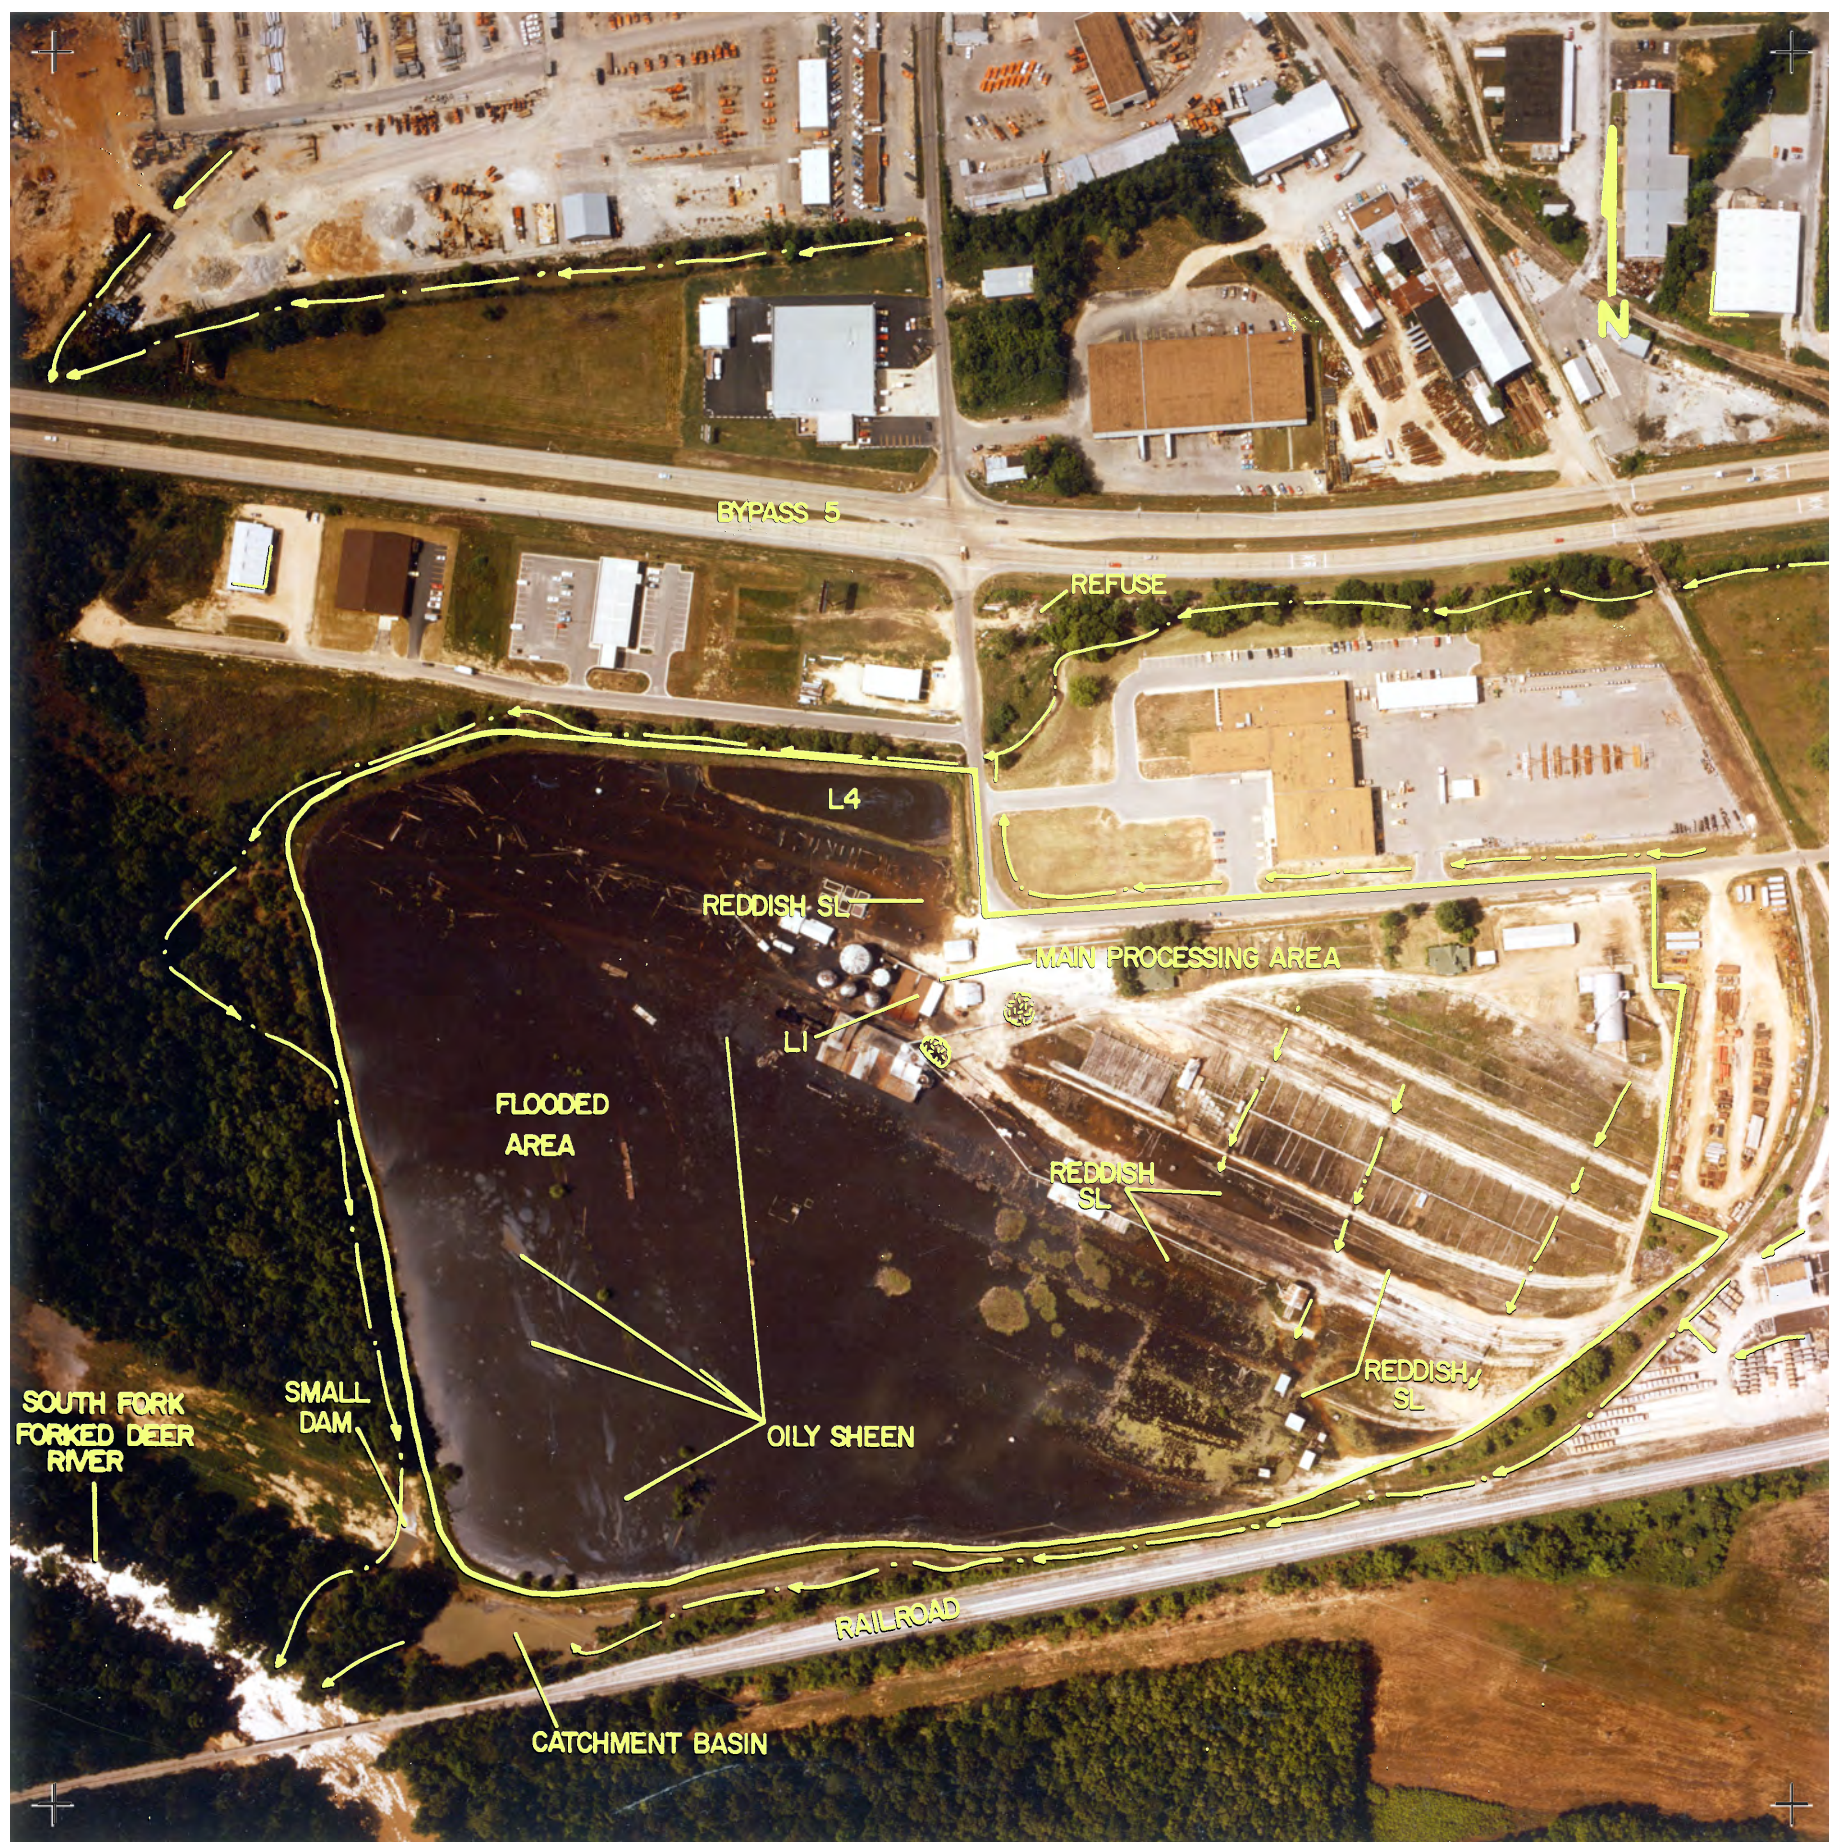
Figure 7. American Creosote Works, June 1, 1983.
Approximate scale 1:3,500.

The western portion of the site has been flooded and the site appears abandoned. An oily sheen is visible on the surface of the water in many places. Areas of reddish liquid are visible along the east edge of the flooded area. L1 contains light- and dark-toned reddish liquid. No stacks of wood remain onsite. Refuse is visible between the north edge of the site and Bypass 5.

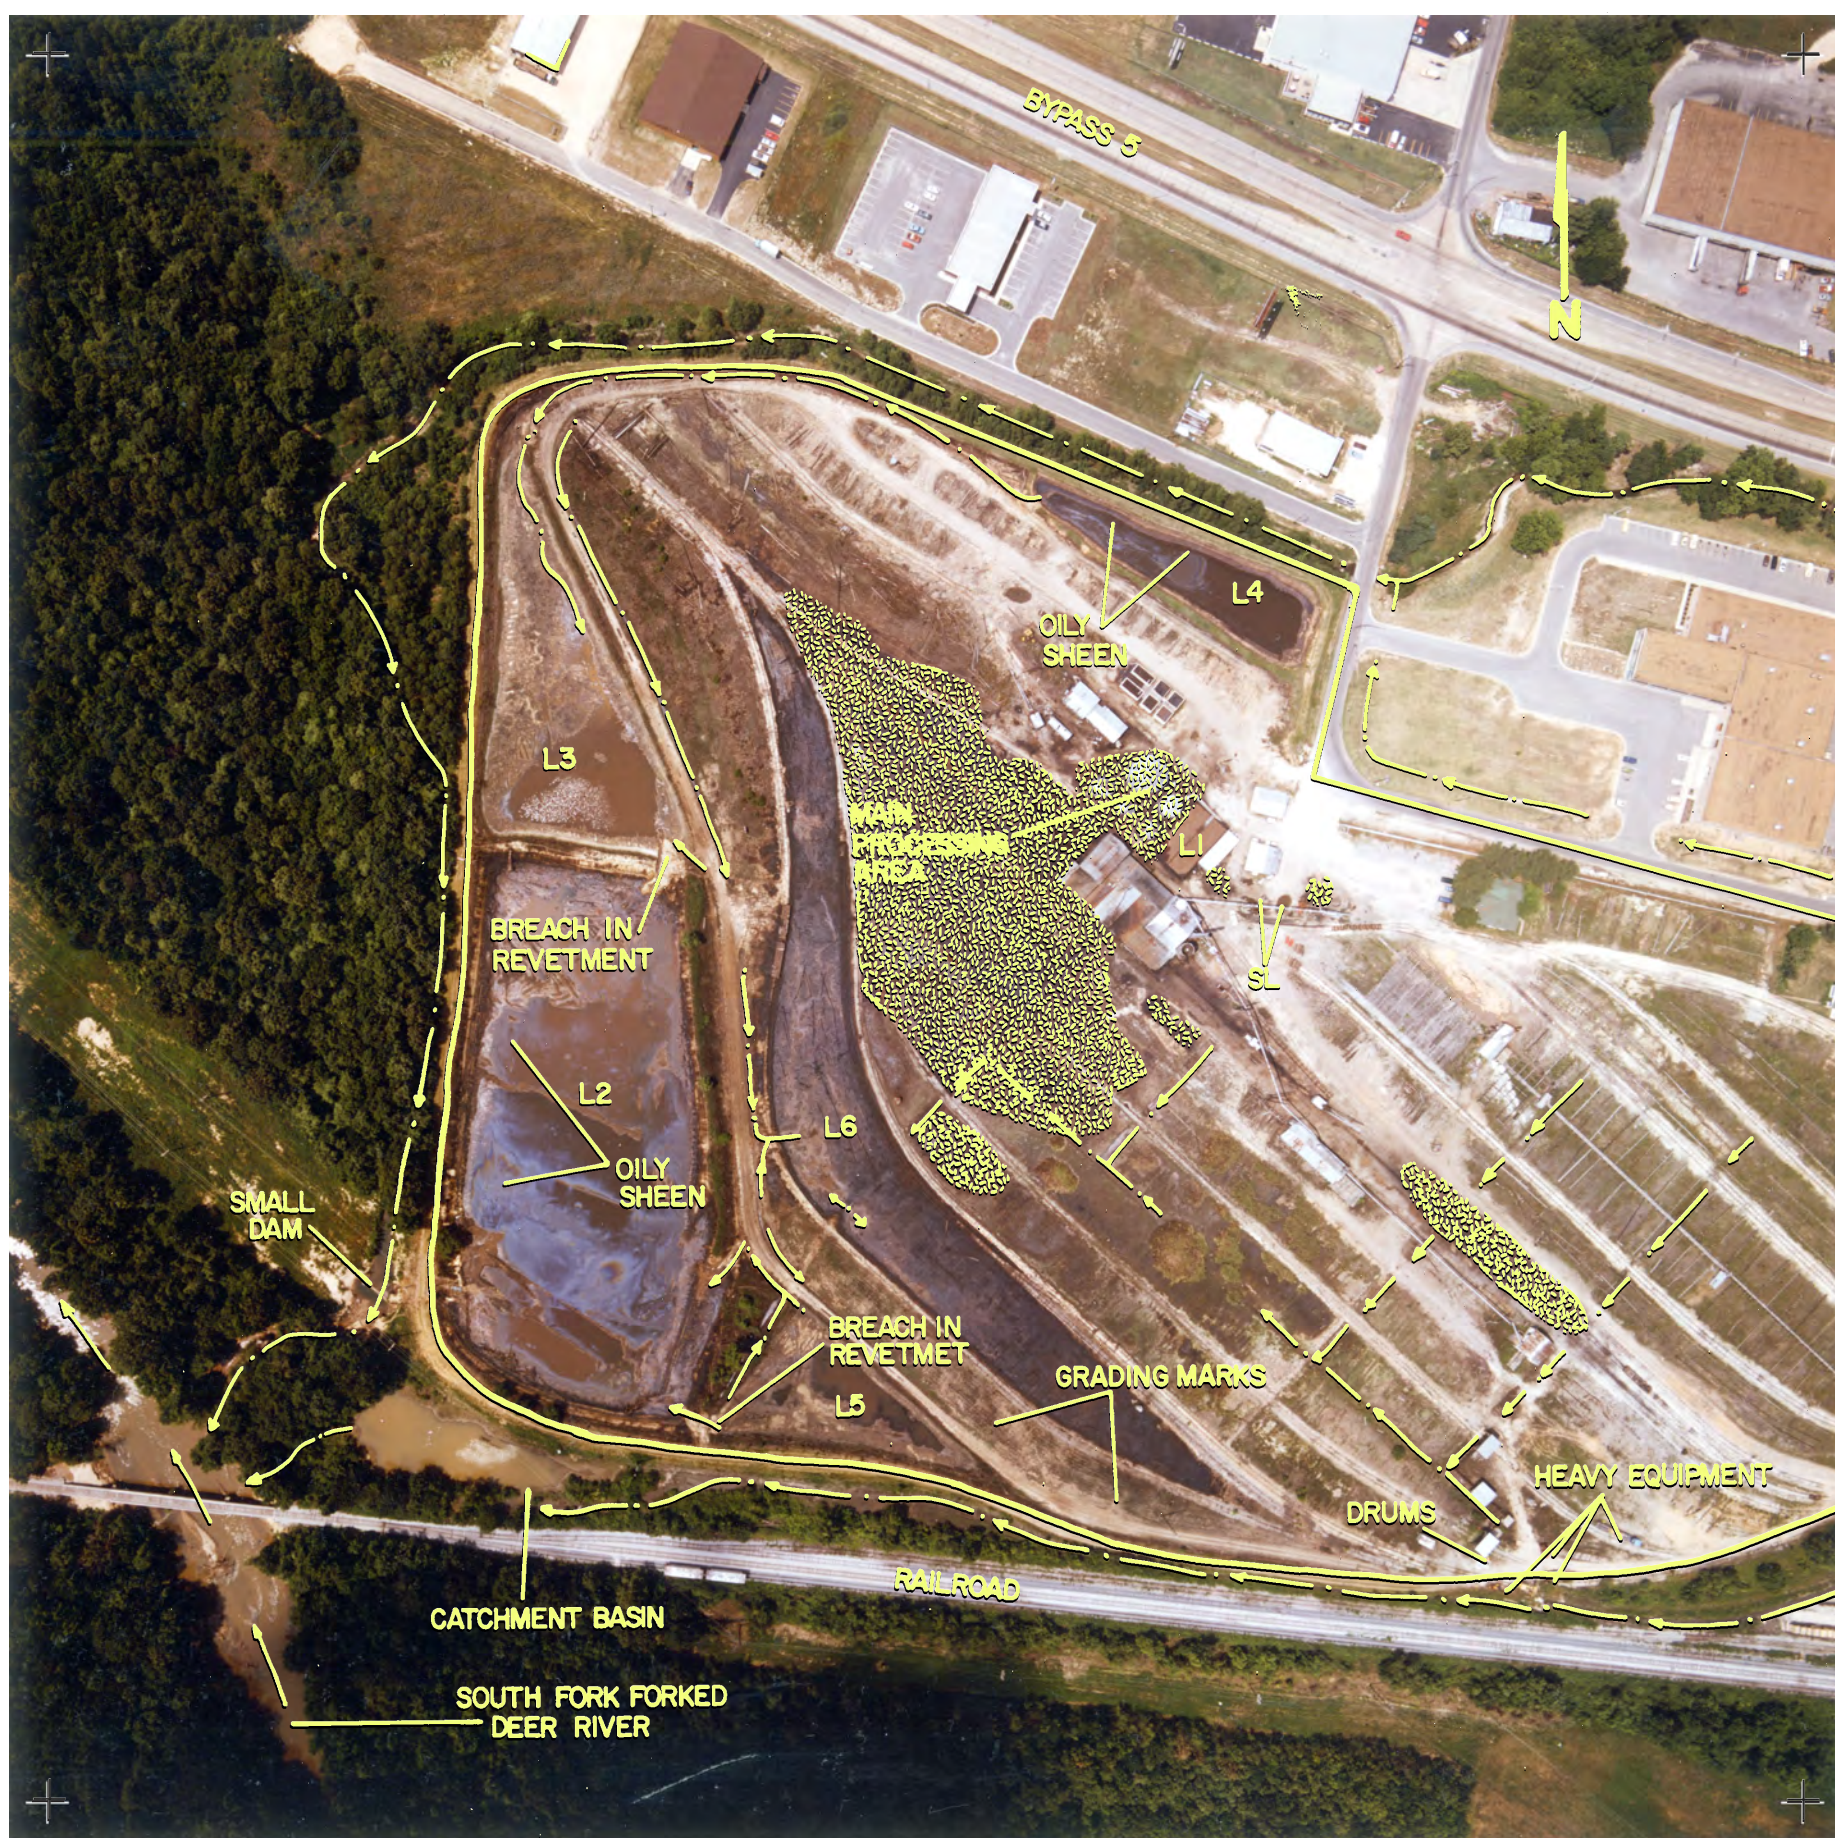
Figure 8. American Creosote Works, June 22, 1983.
Approximate scale 1:2,800.

Remedial clean-up action has begun onsite, and the site is no longer flooded. Shallow pools of liquid are visible in L2, L3 and L5. L4 contains enough liquid to completely cover the bottom of the lagoon. An oily sheen is visible on the surface of the liquid in L2 and L4. Breaches have been cut in the revetments between L2 and L3, and between L2 and L5. L6 contains no liquid; however, the entire area appears very muddy, oily and stained. Two small pools of standing liquid are visible at the main processing area.

A small cluster of drums and four pieces of heavy equipment are visible in the southeast portion of the site.
